Tech Notes

Vol. 1 issue 3 (1 page)

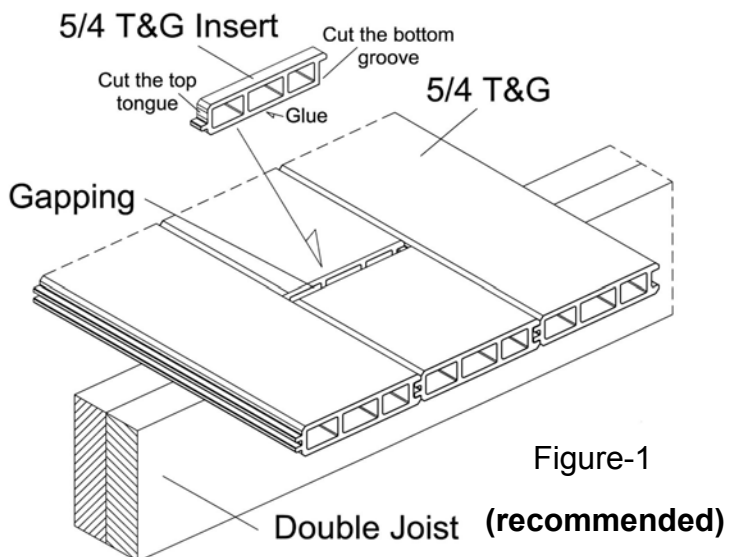
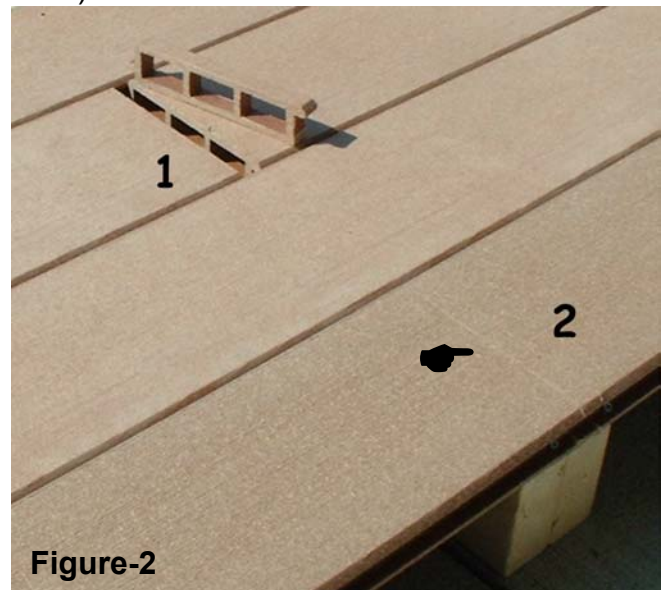
The extreme weather change between winter and summer may cause larger gaps between the butt joints of 5/4 T&G Nexwood board. The wood sub-structure has a potential movement of expansion and contraction depending on atmospheric conditions. The coefficient of linear thermal expansion of 5/4 T&G Nexwood deck board is $2.7 \times 10^{-5} / ^\circ\text{F}$. It means that a 20 ft board at 100°F temperature change will expand or contract about 0.65". (The expansion or contraction will be held by the screws.) Usually the board will move in the direction of least resistance, the screws may bend and do not come back to the previous positions. In this case, the width of the gap may stay and at times greater than 0.25".

1. Measure the gap between the ends of the boards.
2. Cut 5/4 T&G board at the appropriate length. (Fig.2-1: uninstalled)
3. Remove the bottom groove and top tongue of the insert. (Fig-1)
4. Clean the gapping area from dust / dirt.
5. Apply the recommended adhesive (OSI/LePage PL400) at the bottom side of the insert.
6. Place the insert in the gap. (Fig. 2-2: installed)

Remember: This problem can be minimized by constructing the frame with a double-joint where a butt-joint occurs.
